Unearth the No. 1 Cause of Structural Failures

by Walt Keaveny, Risk Manager, MS, PE, PG

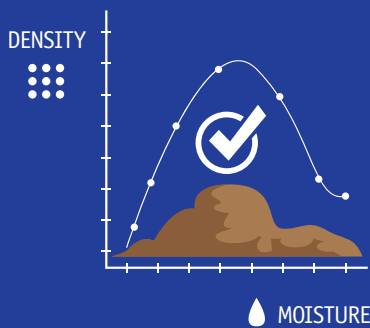
Optimum moisture and density for a particular fill are determined using a Proctor test in a soils laboratory.

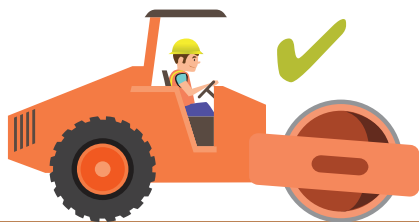
Dozers and loaders spread their weight over wide tracks, or tires, to avoid getting stuck, and are not designed to impart sufficient compactive effort like a true soil compactor.
